ARL-TR-7350 • JULY 2015

# General Atomics Pulsed Power Capacitor Comparison Test Report

General Atomics (GA) has been developing capacitors to meet the demand of these requirements. The latest 3 models of capacitors were tested and their performance is being evaluated to identify a viable candidate for the use in various high voltage applications.

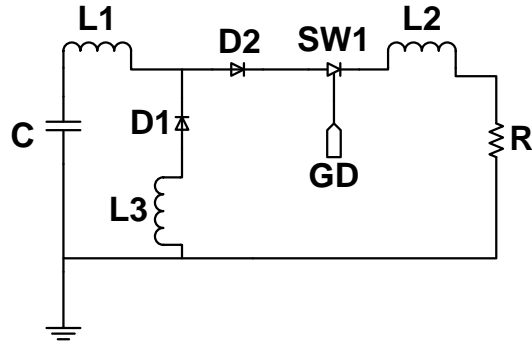
Fig. 1 Test circuit

To properly evaluate how the capacitor will respond to load variations outside of the system, the testbed described in the circuit shown in Fig. 1 was used. This circuit comprises the device under test C, buss inductance L1, adjustable inductances L2 and L3, anti-parallel diode D1, series diode D2, high current switch SW1, and adjustable resistance R. There are 2 extreme waveform characteristics that are used to vet the capacitors. The first of these 2 waveforms is a low inductive load path, which will produce a waveform with a rate of rise greater than 20 kA/ $\mu$ s and no voltage reversal on the capacitor. This requires the circuit to have approximately 70 nH of inductance for L2 and 10 nH for L3 with R at 33 mohm. The other waveform requires a much lower rate of rise but produces a 20% voltage reversal on the capacitor and a much longer current pulse. This requires the circuit load to have approximately 700 nH of inductance for L2 and no change with L3 with R equal to 25 mohms. The test circuit has a buss that can adjust the distance between the buss, thus varying the inductance to the desired level. The reconfigurable load bank consists of 9 different paralleled stacks of 0.1 ohm resistors that can hold up to 0.4 ohms.

discharge life. Furthermore, we varied the inductance in the reverse-current path between the anti-parallel diode and capacitor to produce an increase in capacitor voltage reversal attempting to achieve a 3-kV voltage reversal. The objective buss was replaced by the provided evaluation buss, which increased the voltage reversal to 1.5 kV, as shown in Fig. 10. Eleven discharges were fired with the evaluation buss at 10 kV with a 1.5-kV reversal and a 148-kA forward and 64-kA reversal current. This resulted in capacitance change of 0.1  $\mu\text{f}$  and no change in the dissipation factor, which remained at 0.0073. An additional 450 nH of inductance was inserted between the capacitor and the anti-parallel diode on the return side of the evaluation buss. This yielded 3 kV of voltage reversal at a charge voltage of 8.6 kV. This was achieved by increasing the inductance of L3 in the testbed Fig. 1.

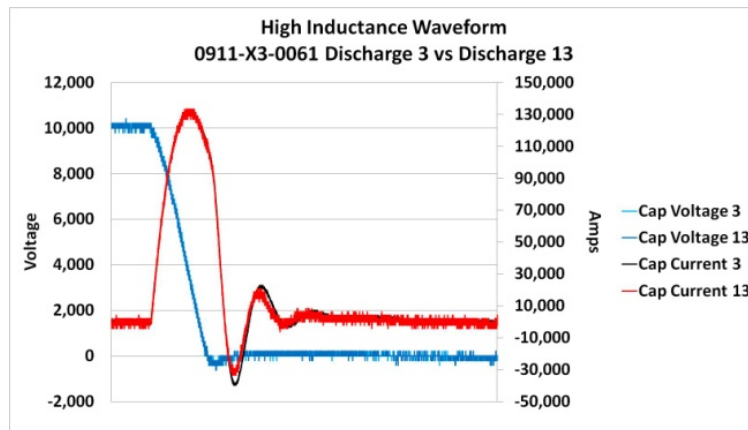
Fig. 2 Cap 0061 discharge 1 vs. discharge 13

This capacitor is designed to have a capacitance of 315  $\mu\text{f}$  with a rated voltage of 10 kV. Serial numbers 0911-X3-0061 and 0911-X3-0064 were subjected to the high inductance circuit, and capacitor number 0911-X3-0057 was subjected to the low inductance circuit. These capacitors were charged, pulsed, and measured for capacitance, dissipation factor (DF), and equivalent series resistance (ESR) to document the change from discharge to discharge. Figure 2 shows the waveform from discharge 3 to discharge 13 on Cap 0061, Fig. 3 shows the waveform from discharge 1 to discharge 11 on Cap 0064, and Fig. 4 shows the waveform from discharge 1 to discharge 8 on Cap 0057. There is what appears to be a slight change in the waveforms over the discharge life; however, Fig. 5 shows that the capacitance loss for each of the capacitors is significant from discharge to discharge and a 10% capacitance loss is reached rather quickly with Cap 0057 only able to supply 8 discharges before the capacitance loss threshold is reached.

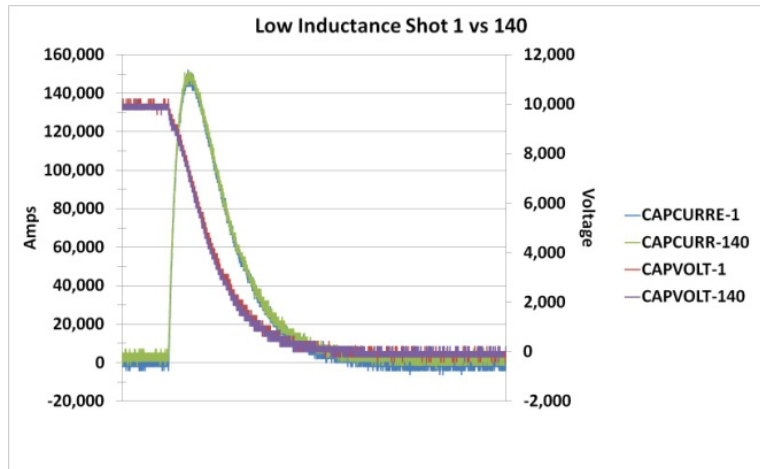
Fig. 6 Cap 8 low inductance discharge 1vs. discharge 140

This model capacitor is designed to have a capacitance of 400  $\mu\text{f}$  at a rated voltage of 10 kV. Two of these capacitors, Cap 8 and Cap 9, were tested, of which Cap 8 was exposed to a total of 458 20 kJ discharges over its life with a total capacitance loss of only 0.007%. Cap 8 was initially subjected to the low inductance circuit, which produces a  $di/dt$  of 22 kA/ $\mu\text{s}$ . Figure 6 shows the discharge comparison between discharge 1 and discharge 140 under these conditions.

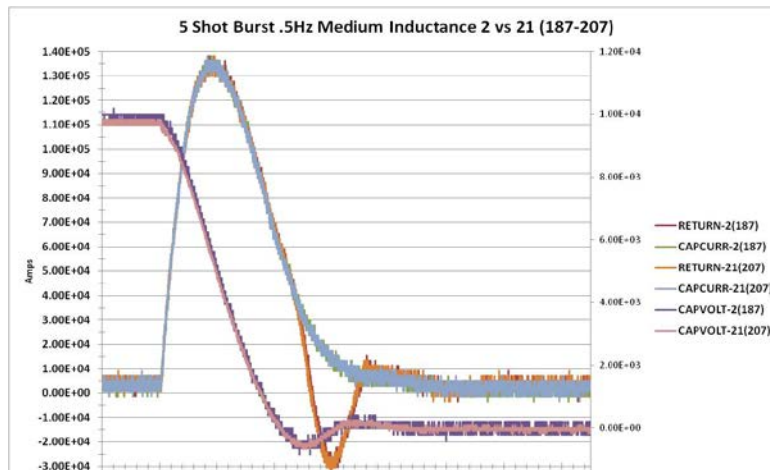
Fig. 7 Medium inductance discharge 2 vs. discharge 21

Cap 8 was then exposed to what was called a medium inductance circuit to see if the introduction of a 30-kA current reversal would degrade the capacitor. This test was done with discharges fired in a burst of 5 at a rate of 0.5 Hz. Figure 7 shows that the capacitor saw no significant degradation after a total of 20 discharges under these conditions with a capacitance change of only 0.005%.

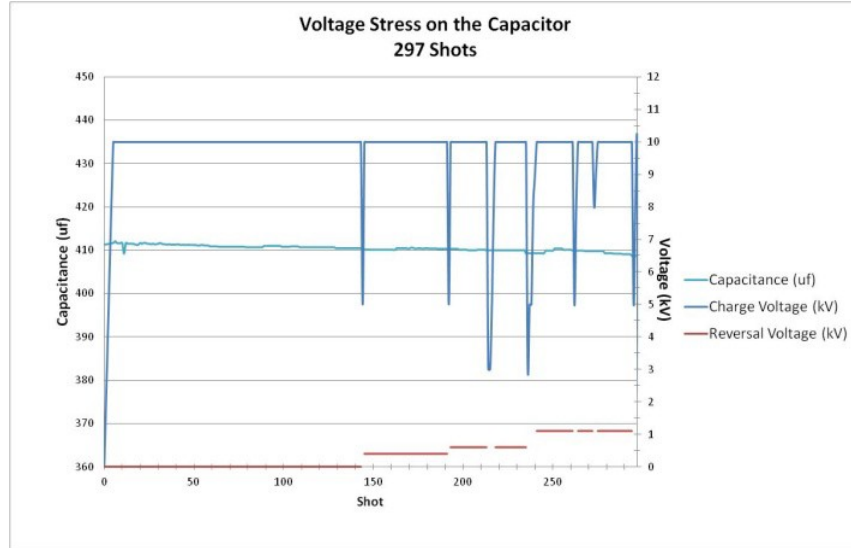
**Fig. 8 Voltage stress on the capacitor**

After more than 280 discharges at 10 kV with reversals up to 1.1 kV and peak forward currents up to 150 kA and peak current reversals of up to 72 kA, as shown in Figs. 8 and 9, respectively, the lifetime of this capacitor was an order of magnitude higher than the expected 20 to 30 discharge limitation (10% capacitance loss). These evaluations resulted in a capacitance loss of less than 0.01%.

Figure 8 illustrates that the voltage reversal across the capacitor was only 1.1 kV with a 72-kA current reversal. This observation (Fig. 8) led us to perform an evaluation that would apply higher voltage reversals on the capacitor to stress the dielectric, which would induce degradation and identify the cause of low

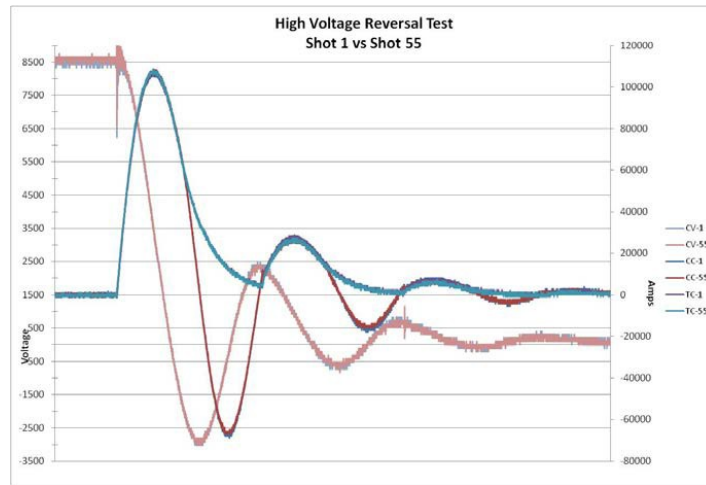
**Fig. 11 High voltage reversal test**

The capacitor was stressed under this condition with a discharge rate of 1 discharge every 10 s after which the capacitance measurements were taken after 10 discharges. The benefit and purpose of this test is to solely stress the dielectric in the capacitor without stressing the end connections due to fact the peak currents are reduced to no more than 110 kA. Table 1 shows a negligible decline in the capacitor changing 0.1 to 0.2  $\mu\text{F}$  after 10 discharges. Figure 11 shows the voltage and current waveforms of an 8.6 kV discharge overlaying discharge 1 to discharge 55, which confirms the stability of the capacitor.

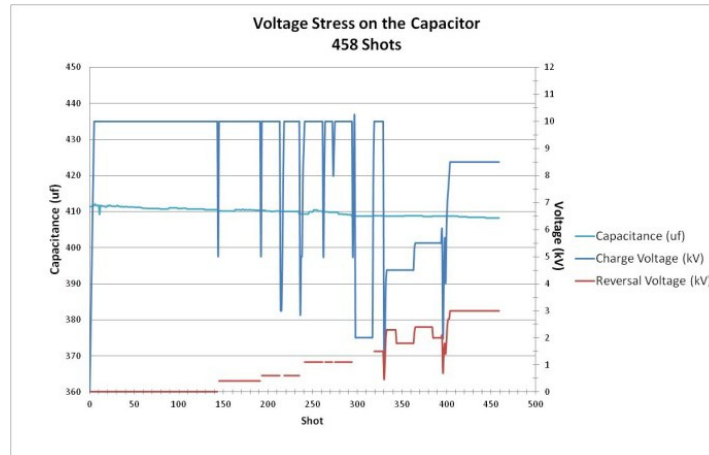
**Fig. 12 Voltage stress on Cap 8**

Figures 12 and 13 show the capacitance over 458 discharges stressed by voltage and current, respectively. Based on Figs. 12 and 13, the voltage and current stress on the capacitor did not induce a large variance in capacitance throughout the evaluation sequence of Cap 8.

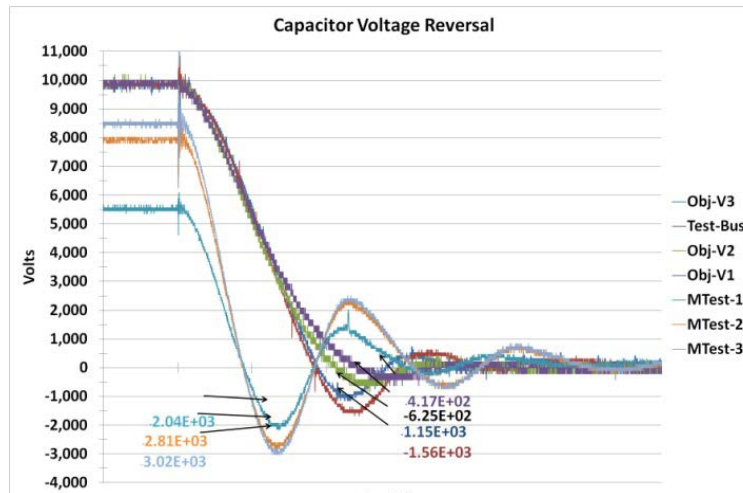
**Fig. 14 Cap 8 voltage reversal**

Figure 14 illustrates the different voltage waveforms that the capacitor endured during high load inductance evaluation. In Fig. 14, Obj-Vx represents different inductances used with the objective buss, Test-Buss represents waveforms generated by the evaluation buss, and MTest-x represents waveforms generated by the additional inductance added to the evaluation buss.

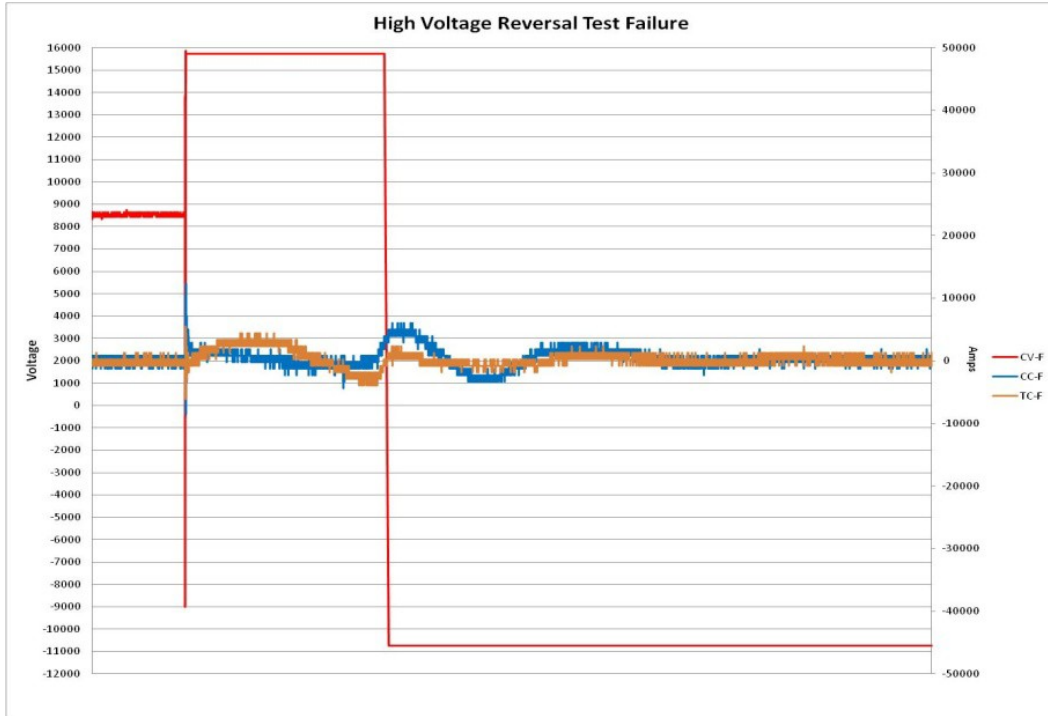
**Fig. 15 High voltage reversal test failure**

On discharge 56 of the 3-kV reversal evaluation, the capacitor shorted out internally during the discharge, as illustrated in Fig. 15. Figure 15 depicts that when the capacitor fault condition happened, a small percentage of current with much lower energy was discharged through the switch (pulse current info attained from Rogowski coil). Figure 15 also shows the saturation of the voltage probe due to the capacitor failure.

Just before failure, Cap 8 had a capacitance of 408.7  $\mu\text{F}$  and a dissipation factor of 0.0078. From these results, we believe that the current density in the end connections internal to the capacitor where not the point of failure. These results point to the inductance in the anti-parallel diode path across the capacitor, which leads to higher voltage reversal on the capacitor thereby damaging the dielectric. Because the objective buss has very low inductance in the anti-parallel diode path, it is expected that discharge life should be well over 30. The pictures in Figs. 16 and 17 show the result of the failure.

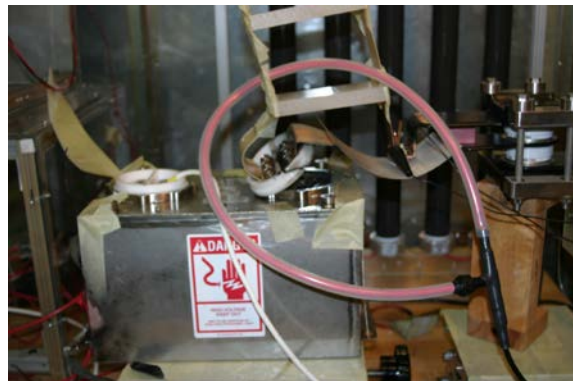
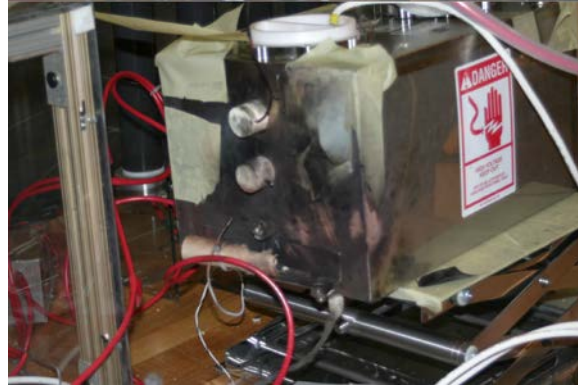
**Fig. 16 Cap 8 failure side view**

**Fig. 17 Cap 8 failure rear angle view**

Capacitor model 38382 clearly has superior performance for the given application showing negligible loss in capacitance far beyond the expected discharge life of the system. However, there is major concern with the integrity of the header of the capacitor given the recent failure of the 2 capacitors. We are in contact with GA to resolve the issue of the voltage breakdown from case to terminal.

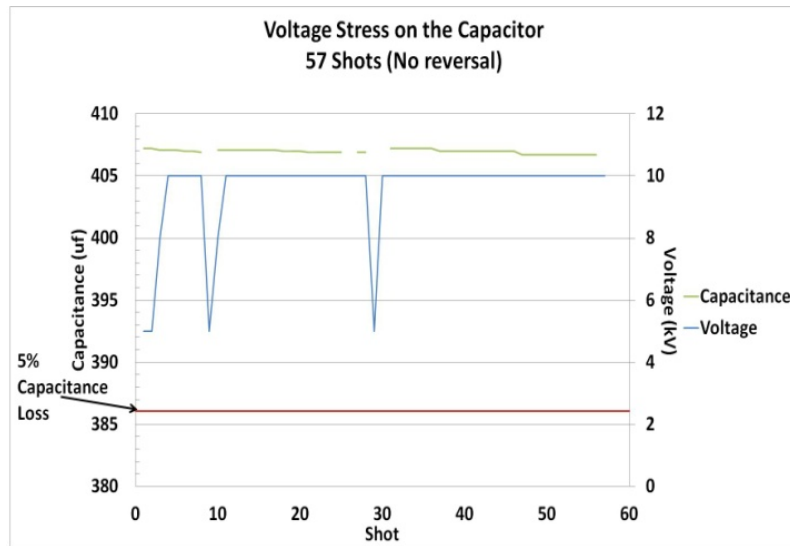
**Fig. 18 Voltage stress on the Cap 9**

Cap 9 was tested in the low inductance circuit with 25 discharges single discharge and then 25 discharges in a burst of 5 at a rate of 0.4 Hz. Figures 18 and 19 show the capacitance loss with respect to the voltage and current stresses respectively. It is clear that Cap 9 is following the trend of Cap 8. Further testing on Cap 9 will take place with other system component integration.

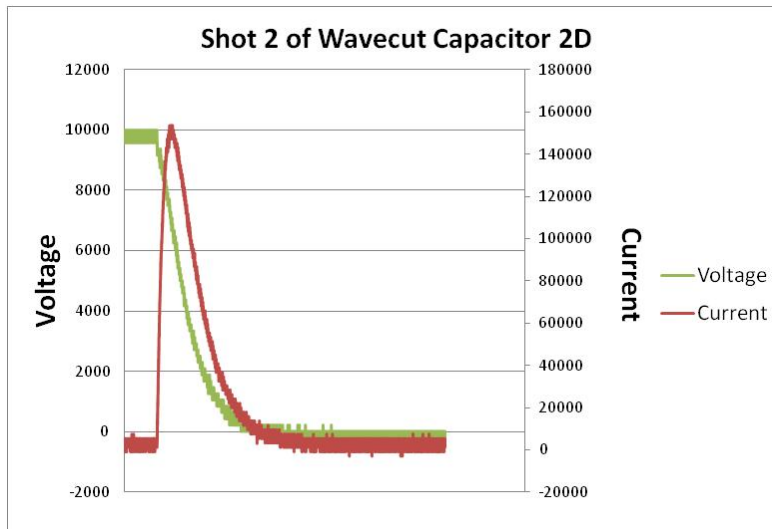
**Fig. 20 Discharge waveform**

The capacitor was then inserted into the discharge circuit where the case of the capacitor was floating respect to the terminals. The discharge circuit produced a high di/dt waveform with no voltage reversal. The capacitor was discharged in 2-kV increments until a 10-kV charge was achieved. Figure 20 shows the full 10-kV discharge waveforms. On the third discharge, the header popped off of the capacitor. The following pictures show the state of the capacitor after this event. After ensuring that the capacitor was fully discharged it was found that the capacitor was in good condition with a capacitance of 405.3  $\mu\text{f}$ , DF of 0.0056, and an ESR of 0.0023. The pictures in Figs. 21 and 22 show the result of the failure.

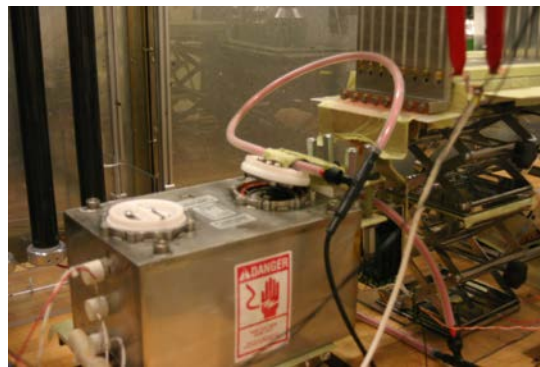
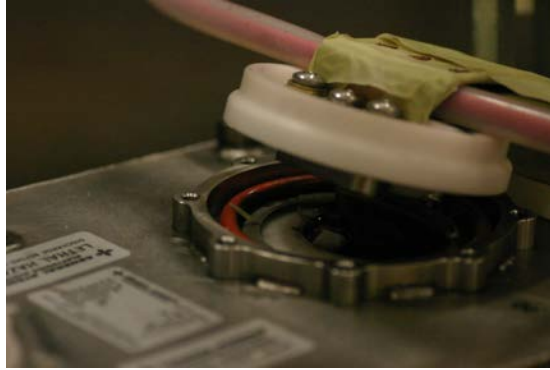
**Fig. 21 Cap 9 failure**

**Fig. 22 Cap 9 failure header close-up**
